## LIVING SHORELINE CASE STUDY

# Mordecai Island

*The goal of this project is to reduce wave energy reaching the marsh edge, capture sediment, and provide suitable habitat for oyster settlement.*

# Beach Haven, NJ: Mordecai Island Living Shoreline

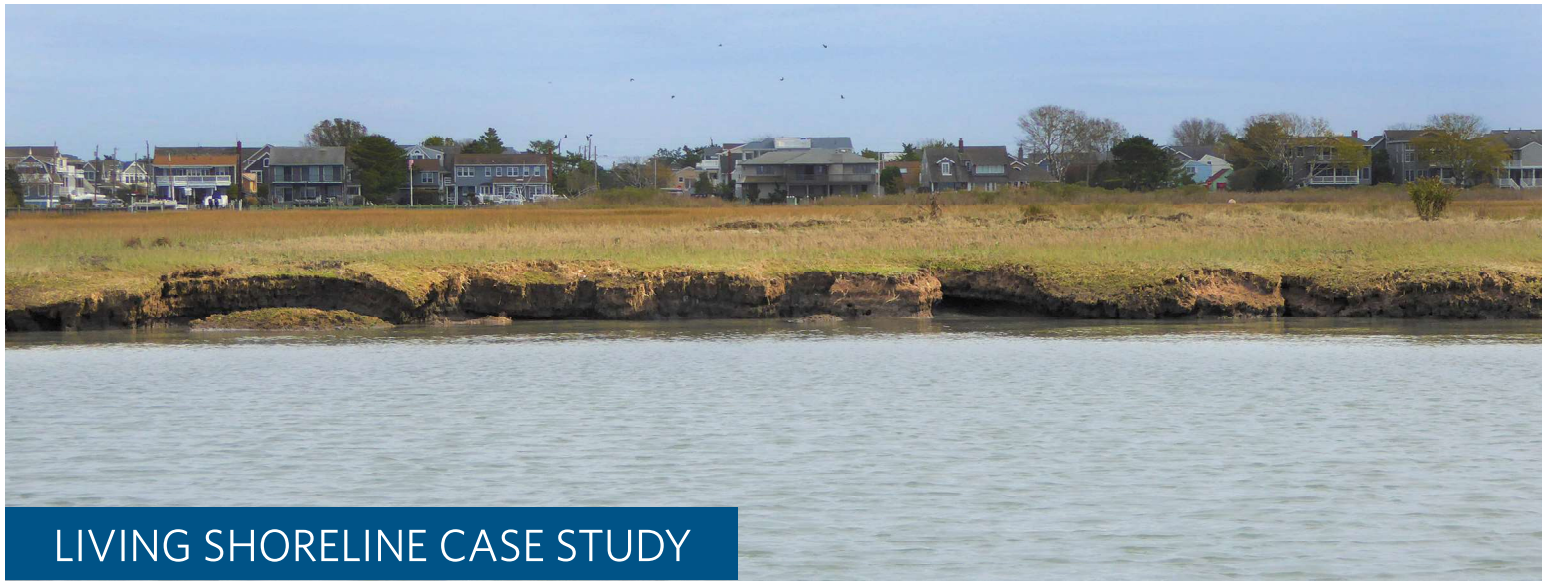
The western shoreline of Mordecai Island: undercutting and slumping of the marsh edge caused by wave energy. © Bill Shadel/TNC

The western shoreline of Mordecai Island had severely eroded over decades from storms and boat wakes (the Intracoastal Waterway was moved closer to the island in 1945). In the mid-1980s, the erosion created a cut that split the island fully in two. Since 2006, the Land Trust has been piloting various natural and hybrid living shoreline projects along segments of the island's western shore.

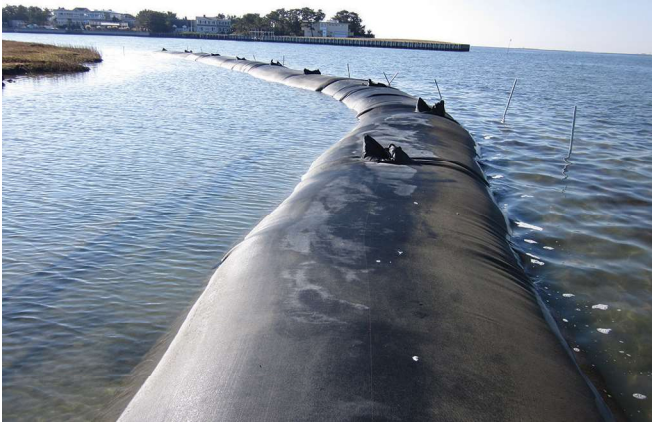
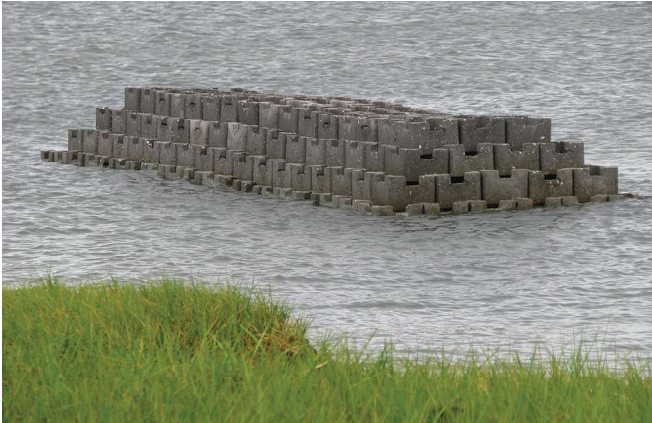
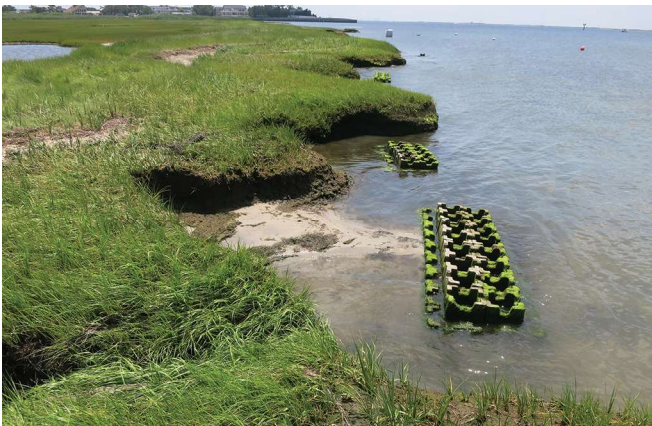
Geotube sills (top): Installed in 2010, two heavy-duty polypropylene tubes filled with fine sand were installed parallel to the shoreline to intercept oncoming waves. Oyster Castle® Breakwater (center): Units were assembled in a larger pod to form a breakwater a few units were seeded with oyster spat to jump-start shellfish settlement (Mordecai Land Trust). Marsh sills (bottom): Oyster Castles® were assembled in smaller pods along the marsh edge to stem erosion, trap sediment, and encourage plant growth (Mordecai Land Trust).

Multiple living shoreline projects were installed along segments of the shoreline. In 2010, sand-filled geotube sills were installed. In 2017, '18, and '19, a series of Oyster Castle® breakwaters and sills were constructed. All of the project management and construction labor was provided by volunteers, saving significant cost.
